### PROJECT STAKEHOLDERS

- Acacia Erosion Control  
Santa Barbara, California

### CHALLENGES

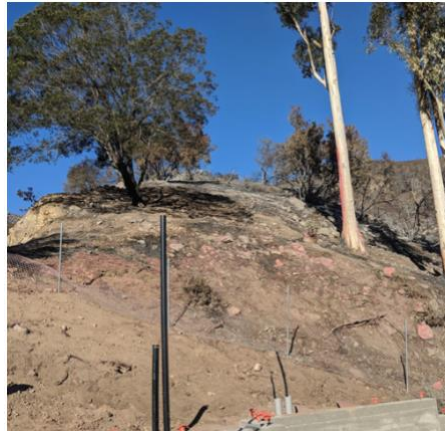
*Before application*

A homeowner in Montecito needed to control erosion and establish vegetation on their property after California's devastating 2018 Thomas fire ravaged the landscape. The two-acre (0.8 ha) site includes rocky hills with 1H:1V and 2H:1V slopes. The construction company working on the house contacted Acacia Erosion Control to survey the site and provide options for reclaiming the land. James Colbert, the estimator and project manager for Acacia Erosion Control, recommended Profile's Flexterra® High Performance-Flexible Growth Medium® (HP-FGM®). Flexterra is the

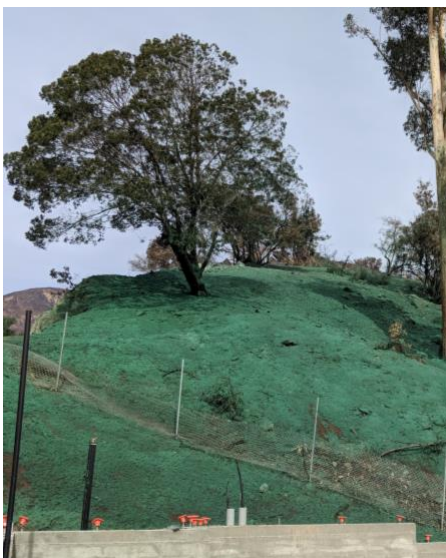
*Flexterra application*

industry's leading hydraulically applied erosion control product, proven to minimize sediment migration and provide highly effective erosion control. Using a 3,000-gallon hydroseeder and three employees, Acacia applied Flexterra at 4,000 pounds per acre (4,480 kg/ha) on the slopes, easily spraying around the burnt trees and shrubs. Colbert said this approach saved time and labor, since his three employees could safely spray product while on stable ground. He said using a rolled erosion control product would have meant using an elaborate rope system, double the labor, clearing much of the debris, and regrading the slope.

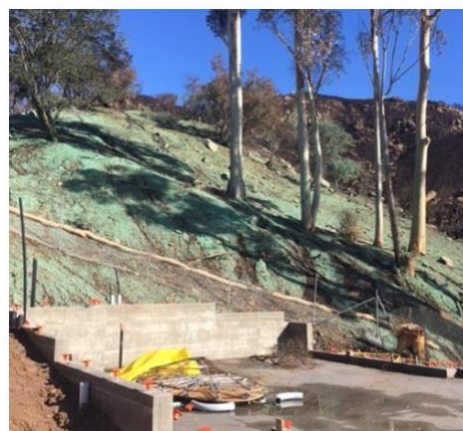
*While rain triggered mudslides in the area, Flexterra remained intact*

Less than two days after application, a major rainstorm triggered massive mudslides in the area, however, areas treated with Flexterra held fast. The homeowners were grateful it saved the property from further damage.
