# Land and Water

# West River Parkway Slope Repairs

On Sept. 1, 2016, more than 2 years after the initial mudslide, West River Parkway was reopened. Many lessons were learned in the design, construction and implementation of this project.

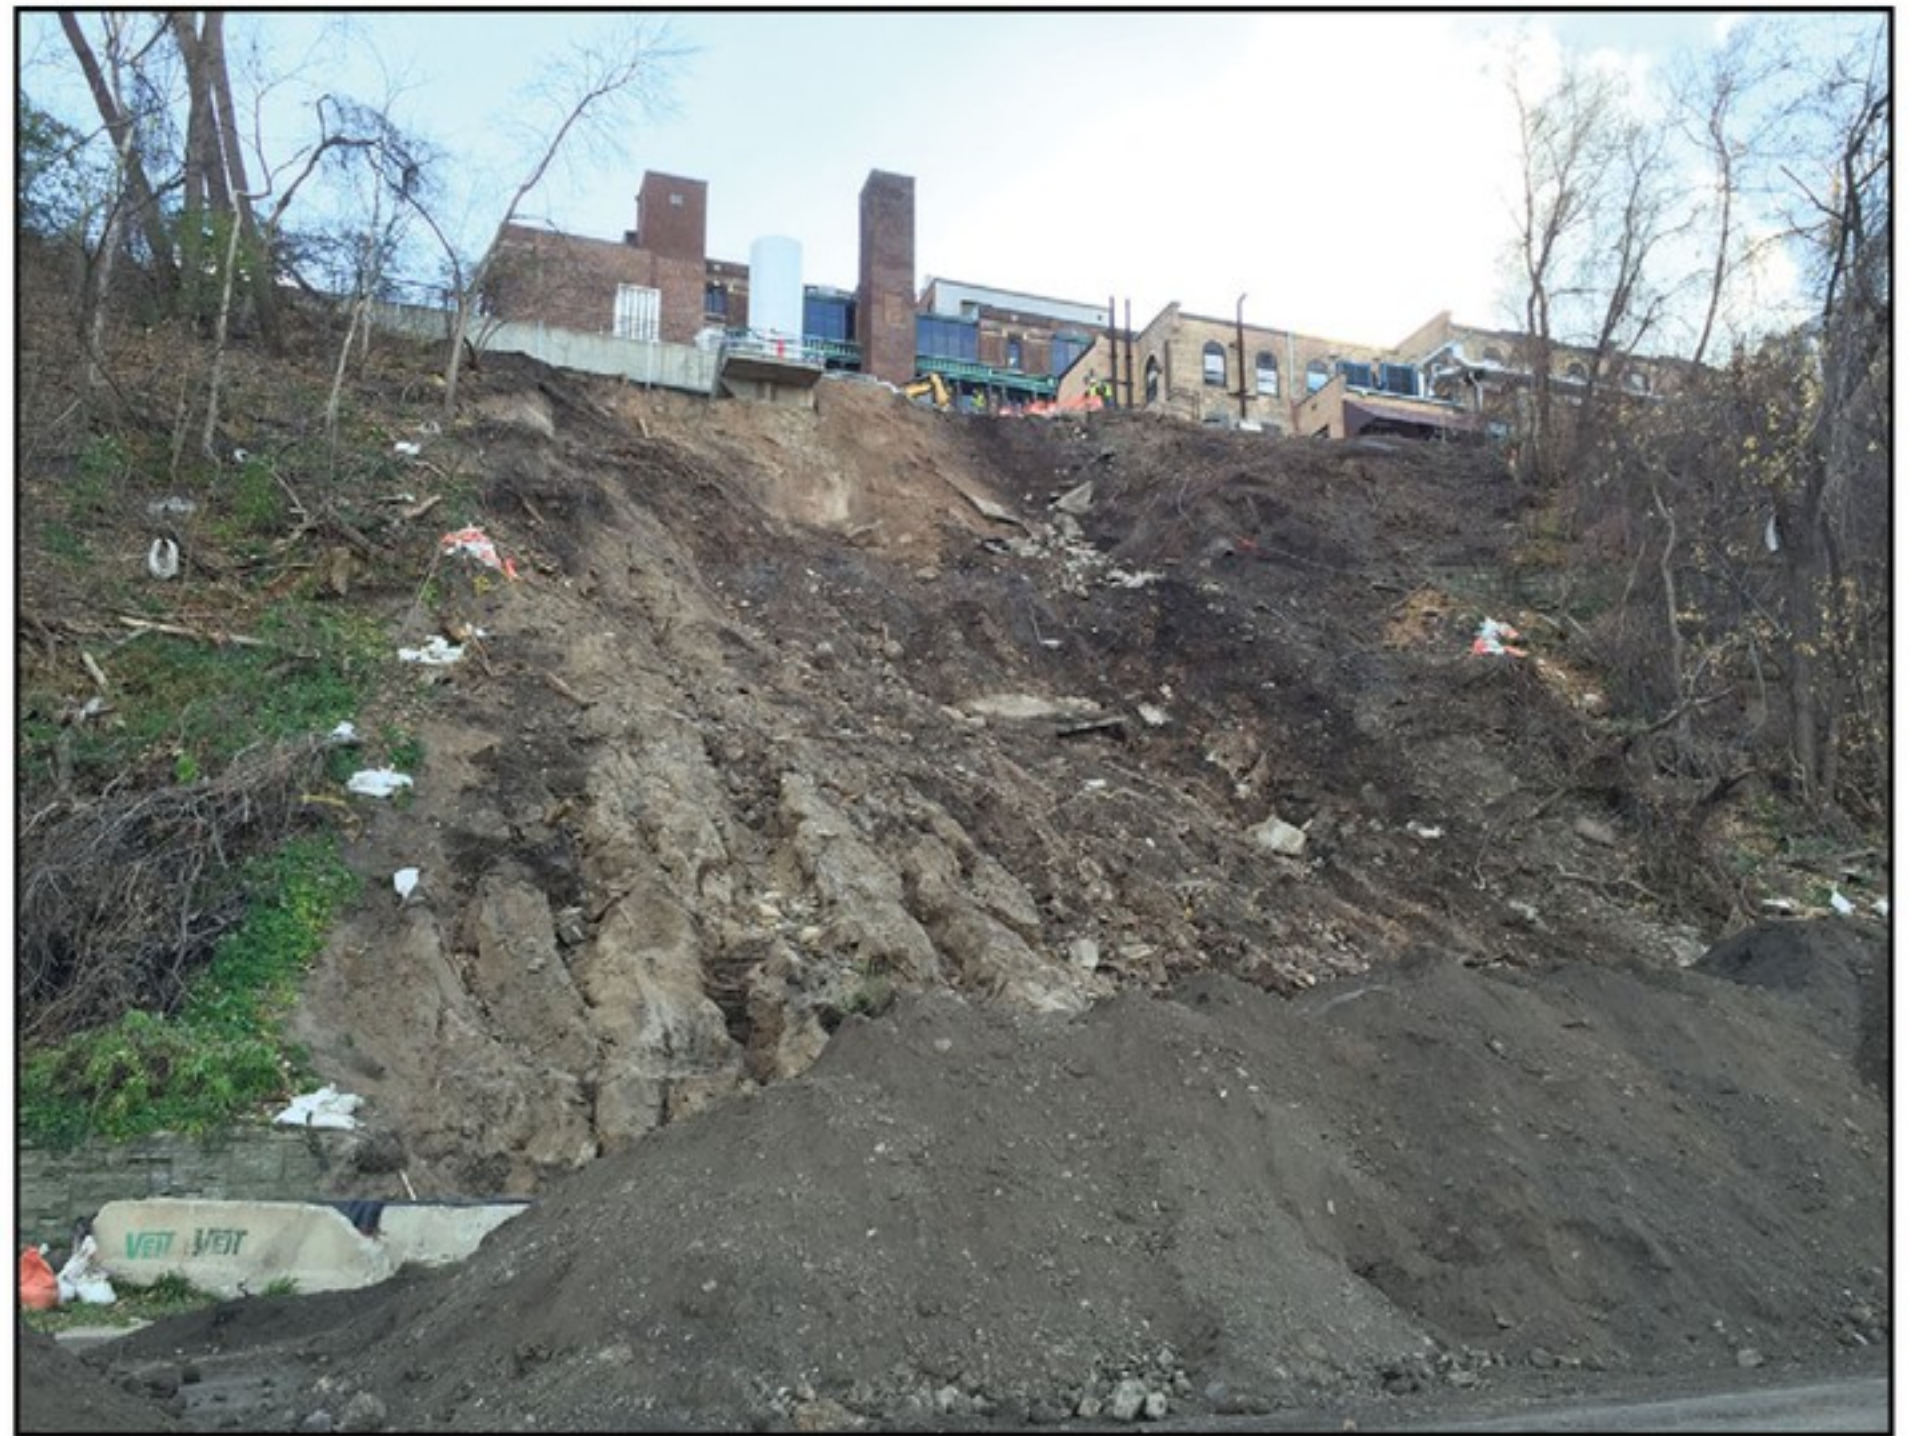
**4,000 cubic yards of soil was dislodged on June 19th of 2014 after 4.2 inches of rain fell on already saturated ground.**

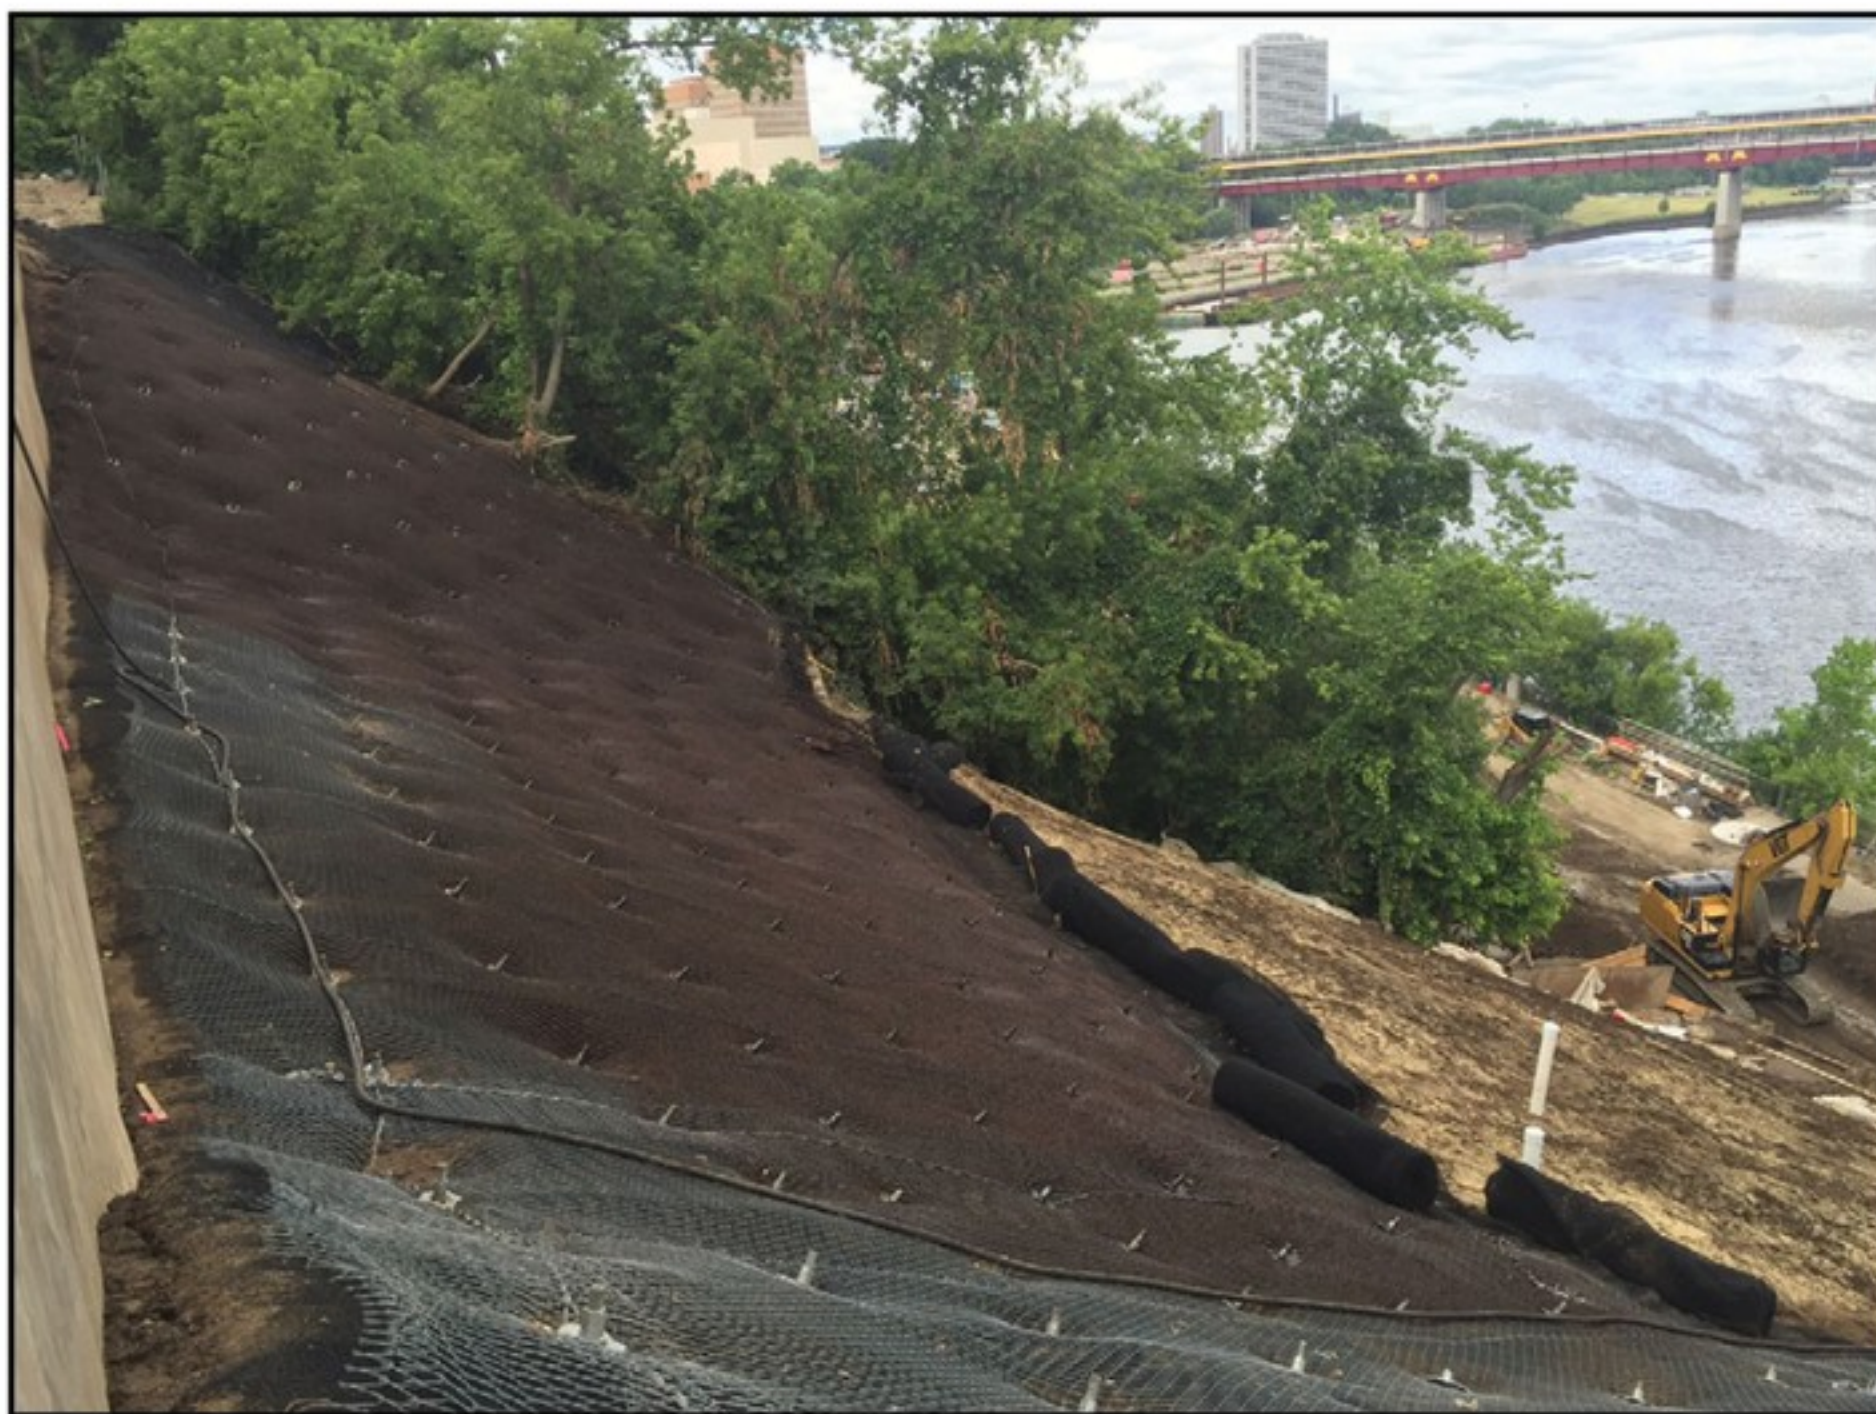
**An erosion control design plan was put into place that would address the temporary needs of the slope and maybe more importantly, the long term sustainability of vegetation on the slope.**

An erosion control design plan was put into place that would address the temporary needs of the slope and maybe more importantly, the long term sustainability of vegetation on the slope. The imported soil was tested for deficiencies, the overland flow was addressed in the vegetated and un-vegetated states, seed specialist Ramy Turf was consulted on proper seed mixture, ero-

sion design software PS3 (profilePS3.com) was used in product determination, and sequencing was aligned with contractors. Barr took multiple factors into account when determining final erosion protection and revegetation plans. The contractor was given strict guidance to adhere to the plans and project specifications with no alternatives allowed.

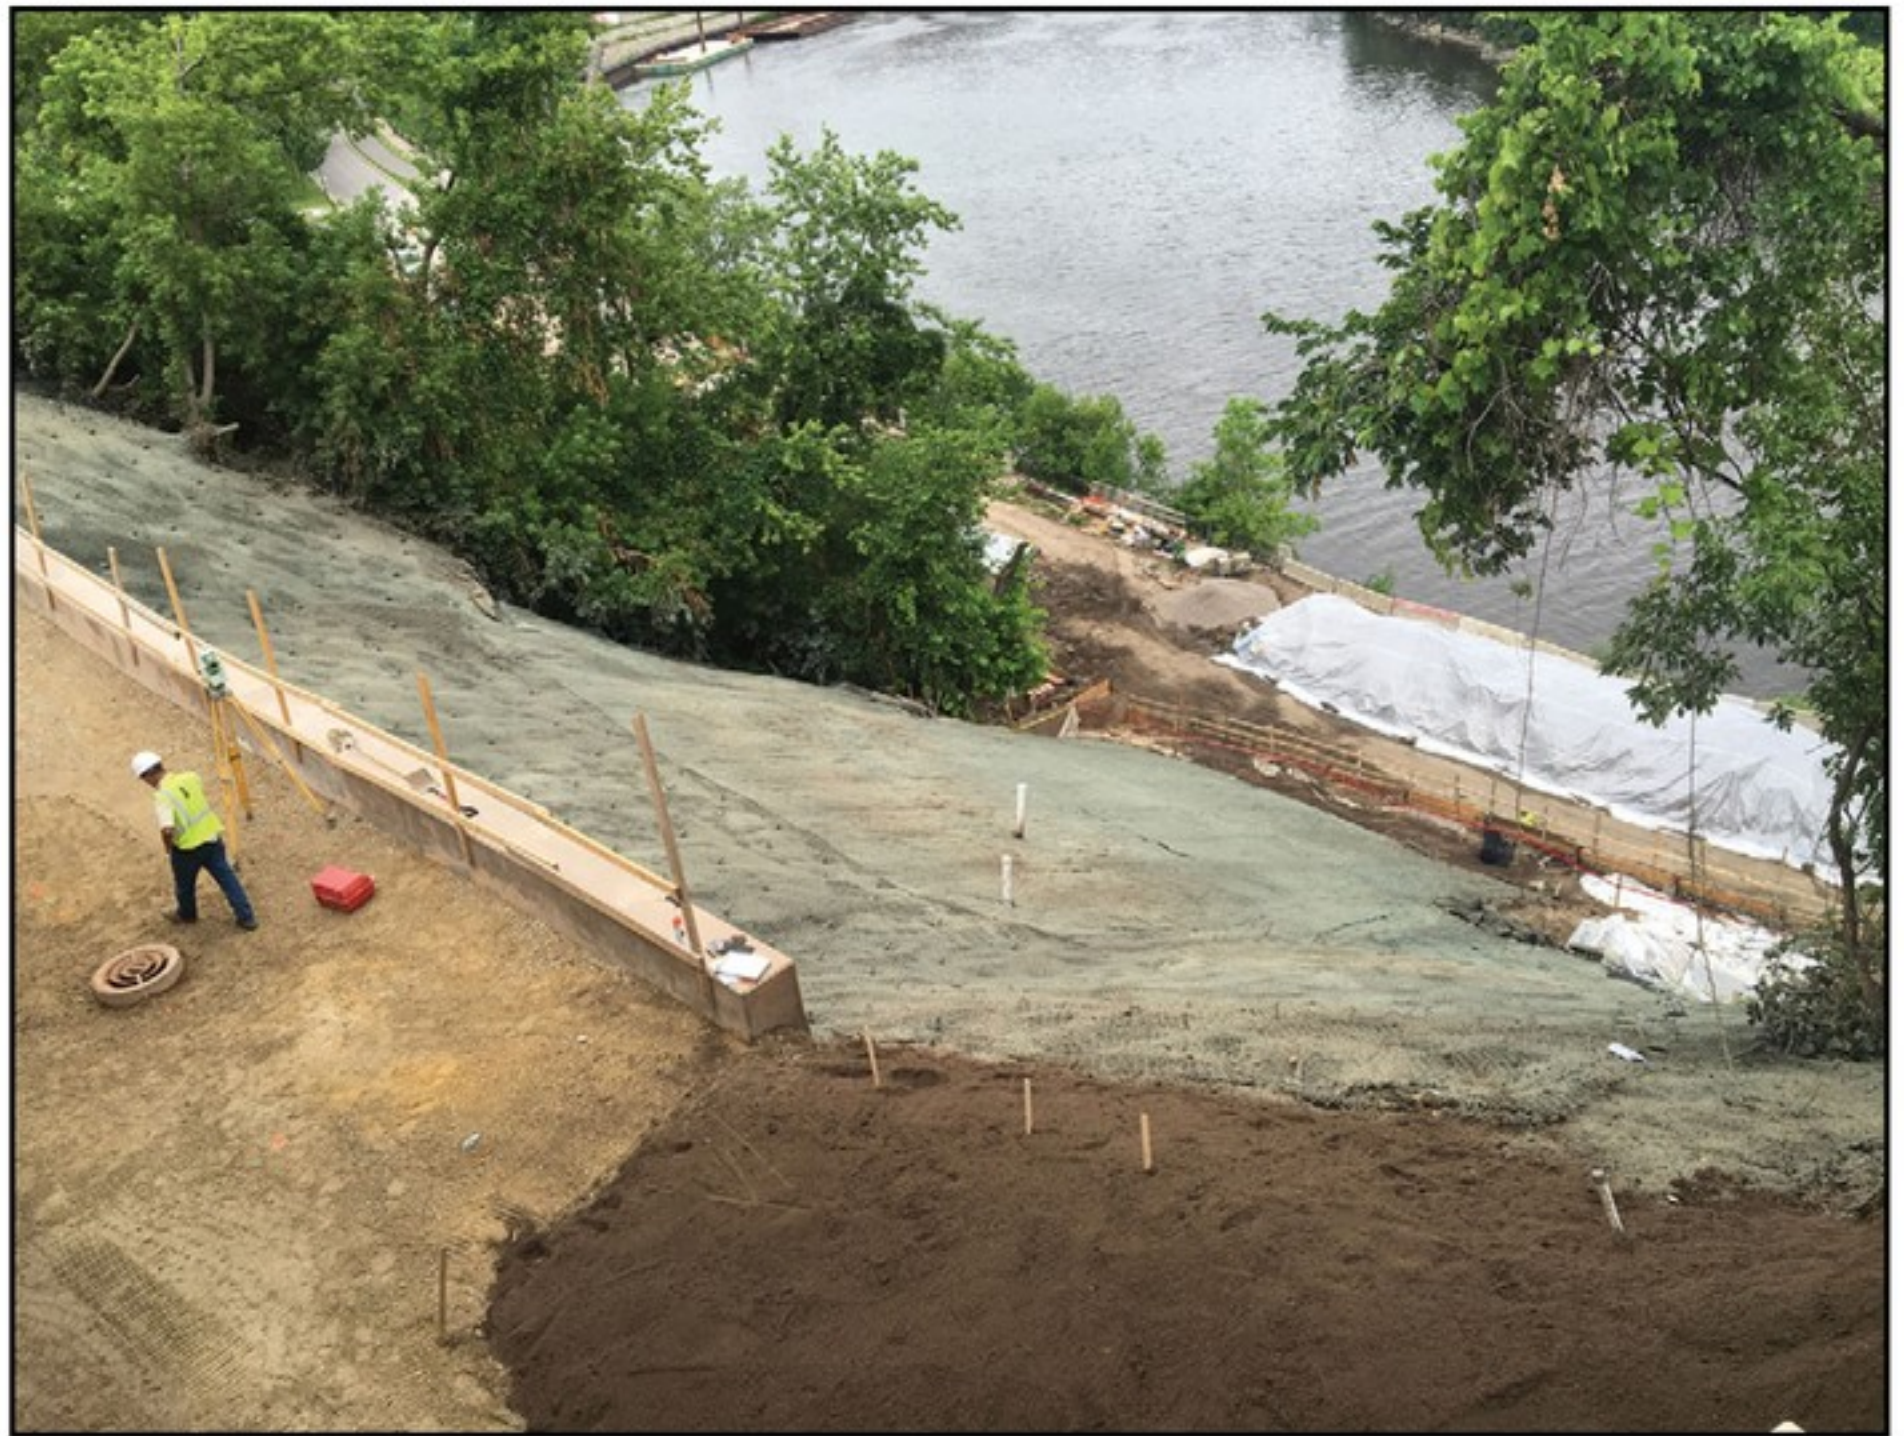
**Barr took multiple factors into account when determining final erosion protection and revegetation plans. The contractor was given strict guidance to adhere to the plans and project specifications with no alternatives allowed.**

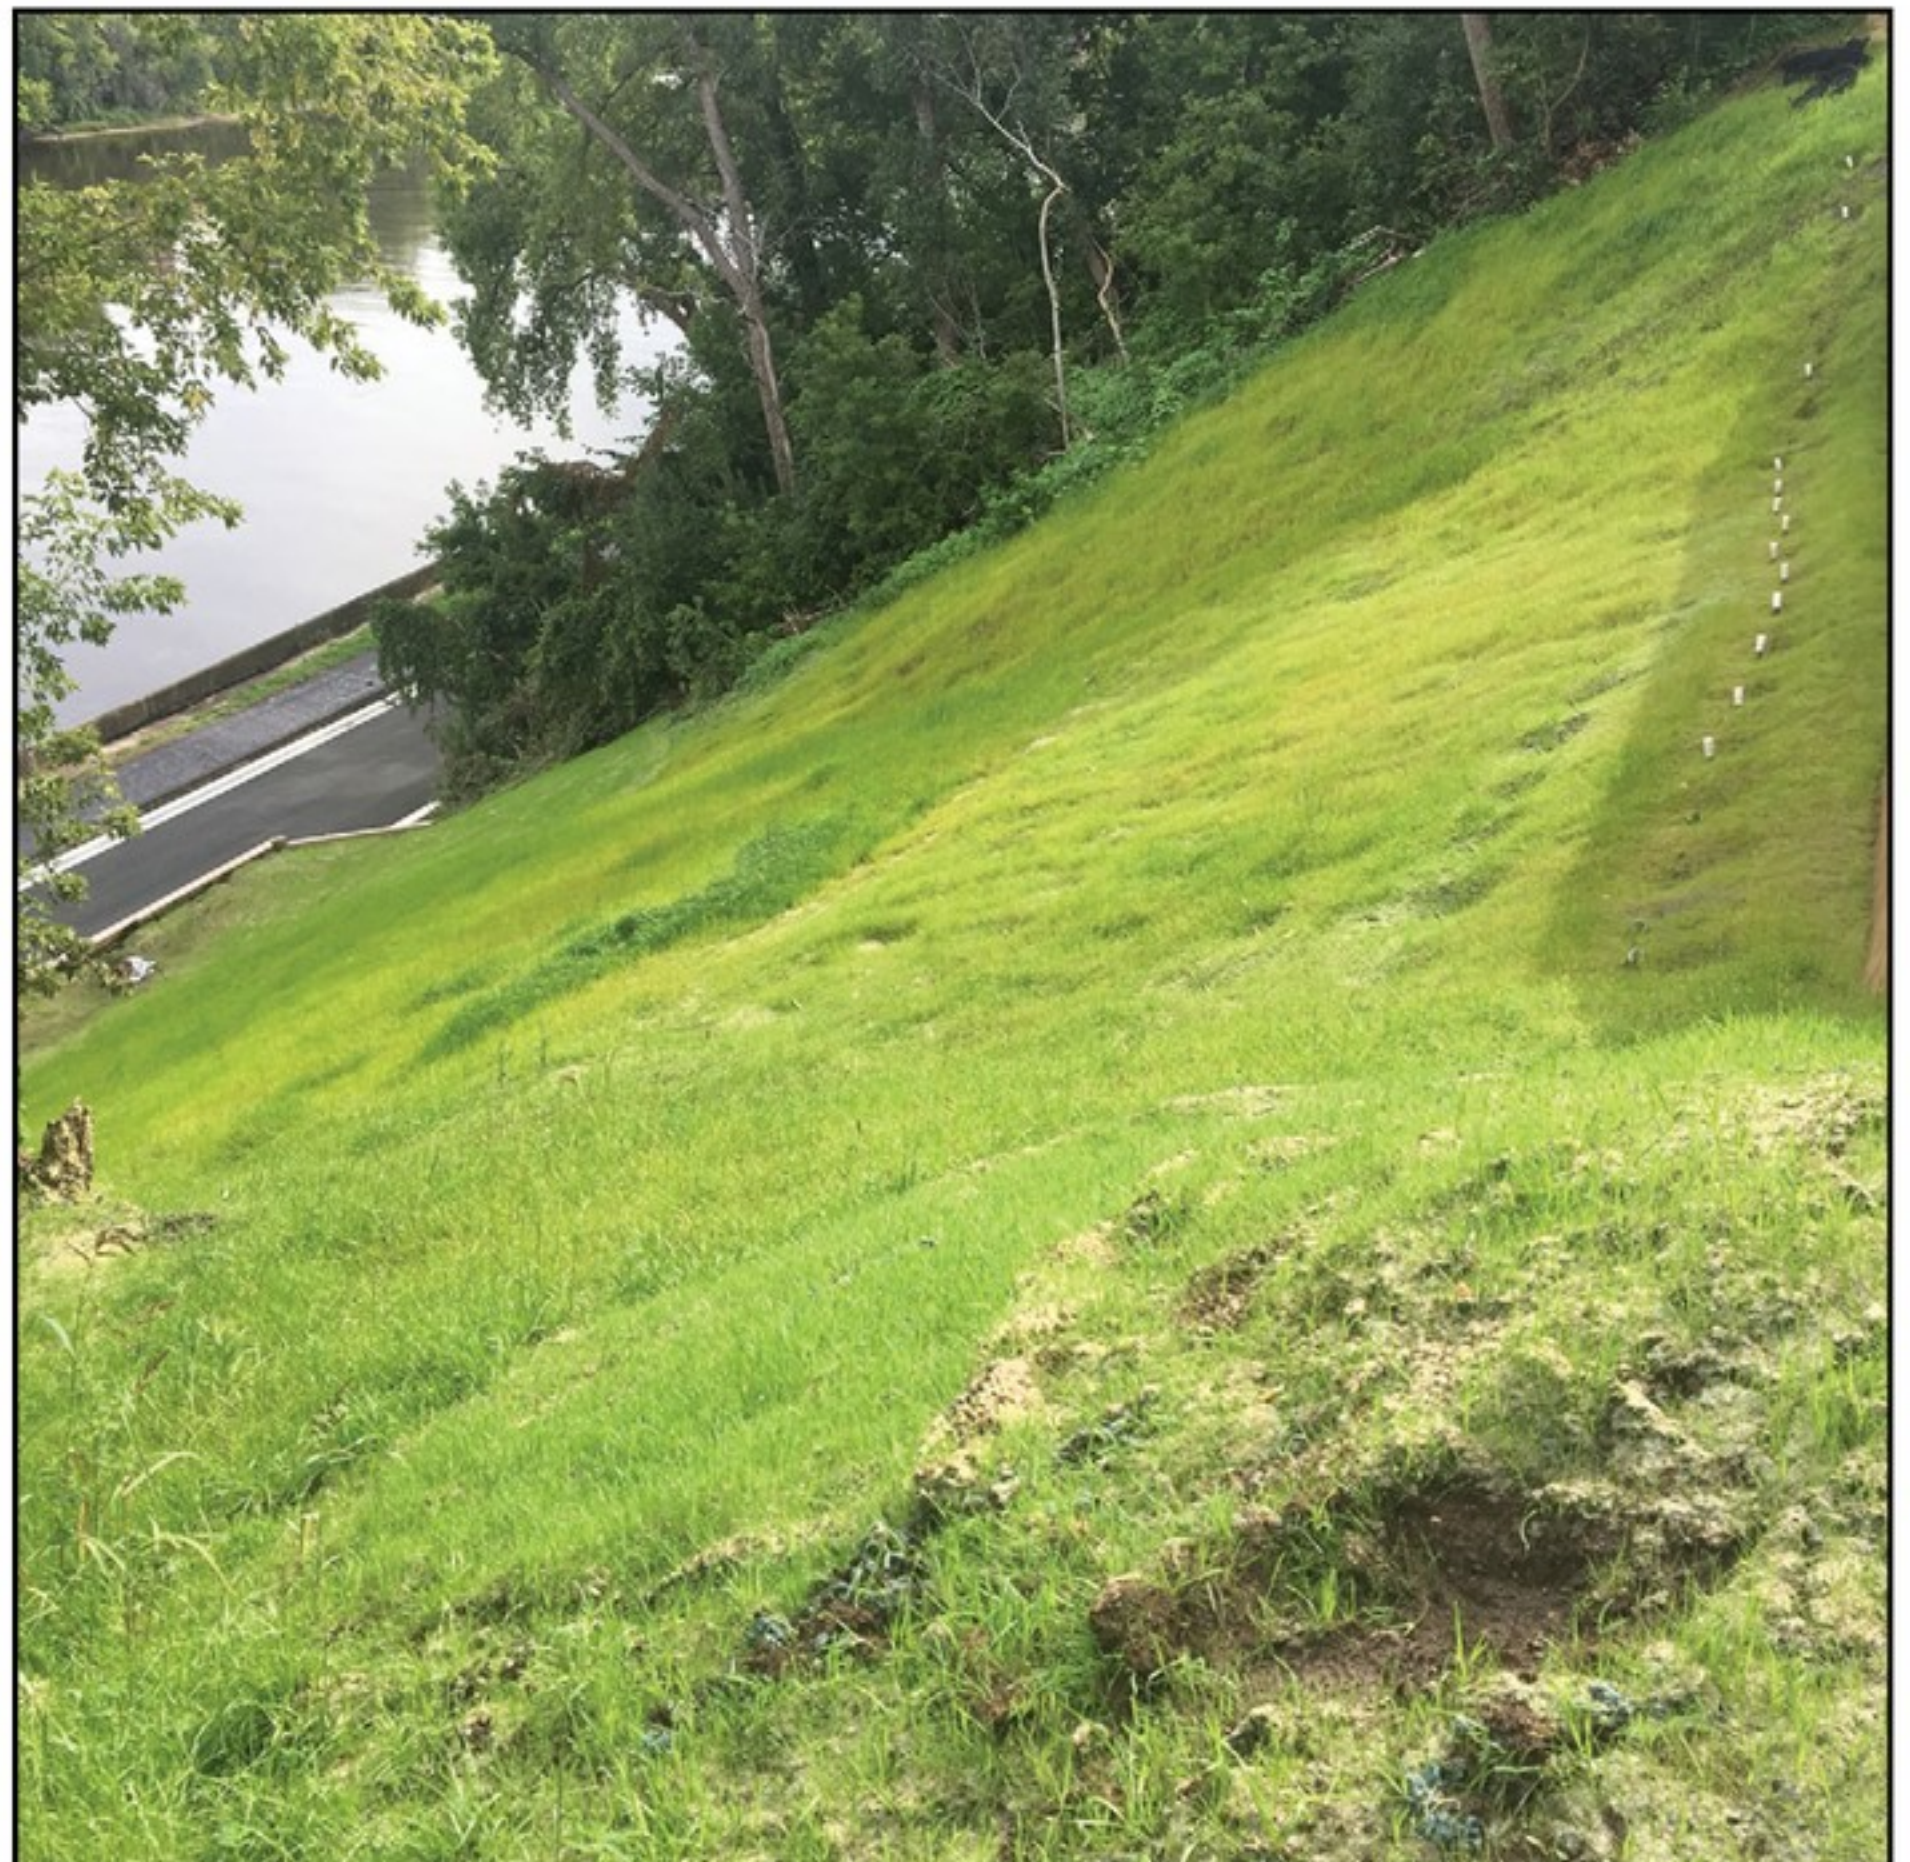
**The teamwork and communication throughout the project by all parties made a very difficult project an ultimate success.**
