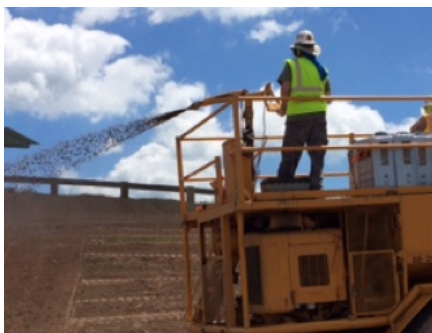
Top: Construction on the resort  
Bottom: ProGanics application on a slope

Profile's partners also took multiple soil tests across the site and found several areas with deficient soils. To restore the soil, the team applied ProGanics® Biotic Soil Media™ (BSM™), an Engineered Soil Media™ (ESM™) that provides the organic matter and soil-building components to modify the soil chemistry and initiate growth and sustainable vegetative establishment. With the long winter on the horizon, a team of hydroseeding companies quickly worked to apply the ProGanics and Flexterra to the site. Within a few weeks, vegetation began to establish. The engineering firm noted the Flexterra application held the seed and soil in place, eliminating worries about sediment pollution. During follow-up inspections in 2018, the site had established sustainable vegetation. The success of this project earned Profile the opportunity to consult on additional projects on the site over the next few years.

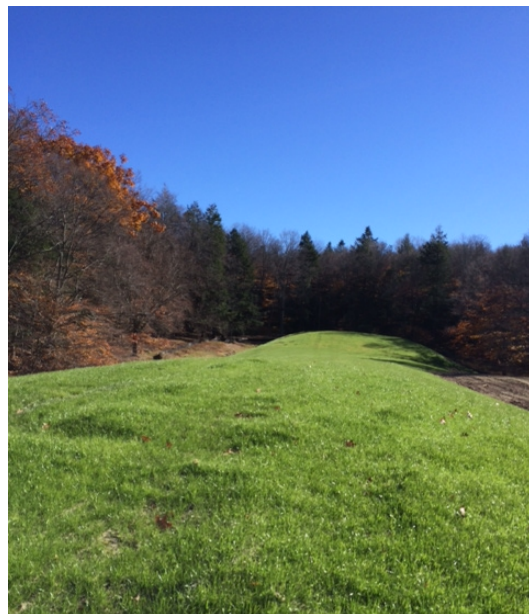
Vegetation began to establish within weeks of application, and the site was fully vegetated in follow up inspections one year later

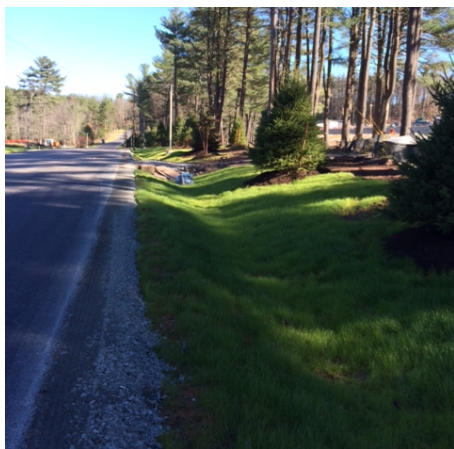
Follow-up inspections saw significant growth, including along the roadways
