The remote Norway House Community wanted to quickly get two baseball fields ready for action. Neither field had any grass and only one site was irrigated. Project organizers wanted to utilize sod so the fields could be playable as soon as possible.

The town is more than eight hours from any major city, and it was determined that trucking in topsoil would have been very costly. Profile® stepped in with a new solution that had never been tried before: applying ProGanics® Biotic Soil Media™ (BSM™) underneath the sod. ProGanics is an Engineered Soil Media™ (ESM™) that provides organic matter and soil-building components to modify the soil chemistry and initiate growth and vegetation establishment. After meeting with Profile, Norway House agreed to this unique approach.

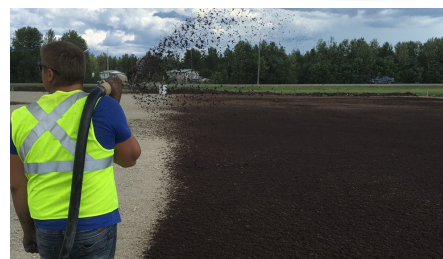
*Application day*

The team applied ProGanics to the irrigated baseball field and then laid the sod. Despite concerns that the roots wouldn't develop past the ProGanics, one year later, the baseball diamond had strong root development that reached into the native soil. The same solution was applied to the unirrigated field.

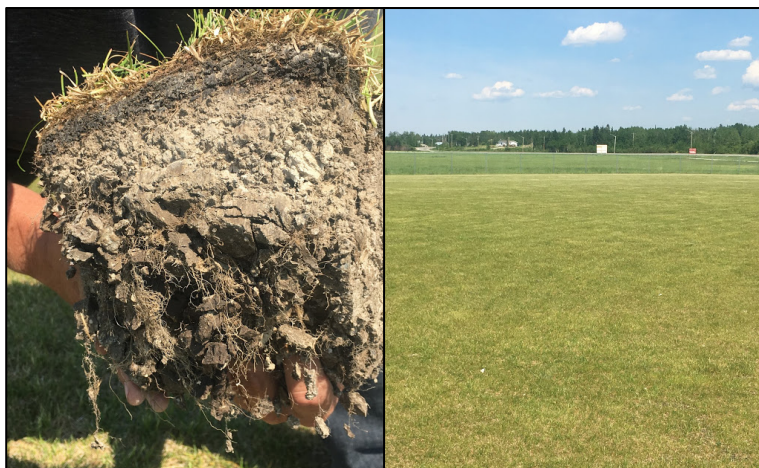
*Results one year later on the unirrigated site*

Despite the lack of irrigation, the root system again developed through the ProGanics into the native substrate, providing a well-established and safe field for the Norway House Community. Two years later, the fields continue to thrive. Neighbors are able to play on the fields throughout the summer with no issues, proving this unique solution to be a viable one.

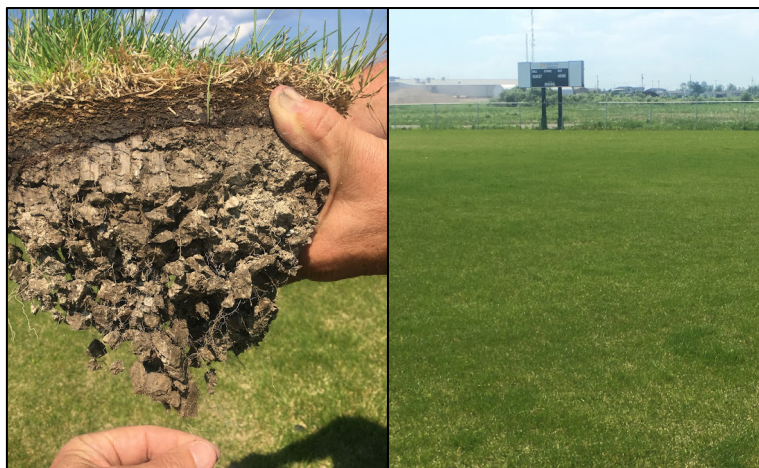
*Results one year later on the irrigated site*
