#### PROJECT STAKEHOLDERS

- Evergreen Power Seeding Pty Ltd
- BHP Mining Company
- PGG Wrightson Turf

Peak Downs is one of the largest coal mines in Australia. In May 2017, the owner needed a revegetation solution for five hectares (12 acres) of the site. He wanted to develop a solution that was different than the conventional mining reclamation method of spreading topsoil and rip seeding. The site did not have abundant topsoil and importing material would have been expensive for the remote site. PGG Wrightson Turf worked with Profile Products to develop a solution to fulfill the site requirements. Given the mine's poor soil conditions, the contractor decided to hydraulically apply ProGanics® Biotic Soil Media™ (BSM™) as an alternative solution to trucking in topsoil.

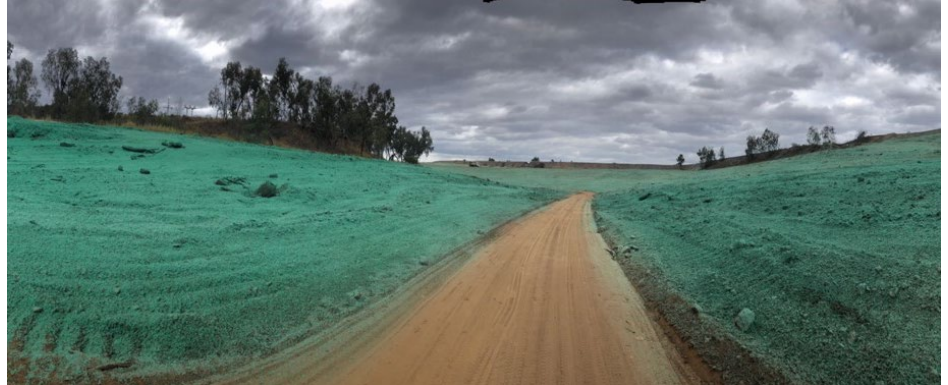
*ProMatrix Engineered Fiber Matrix is applied to the site on top of the ProGanics Biotic Soil Media*

ProGanics is an Engineered Soil Media™ (ESM™) that provides an abundant source of organic matter and soil-building components to modify soil chemistry and initiate plant growth. The contractor also applied ProMatrix™ Engineered Fiber Matrix™ (EFM™) to protect both seed and soil from erosion. The applications were done prior to the wet season which gave the site ample rainfall. Within three months, all five hectares had established vegetation. The project manager was complimentary of the solution and chose to install ProGanics on more than 20 hectares (49 acres). He also brought neighboring mine operators to look at the rehabilitation and learn from its success.

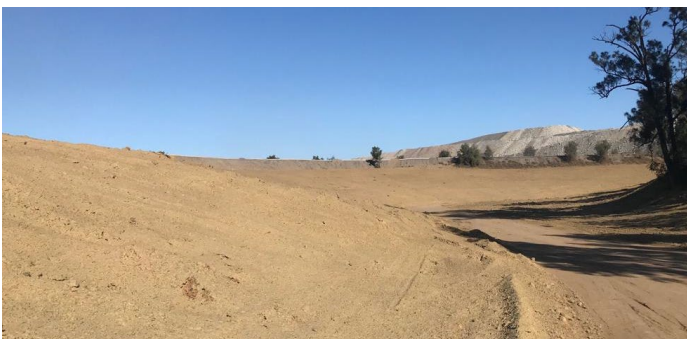
*The barren mine prior to application*

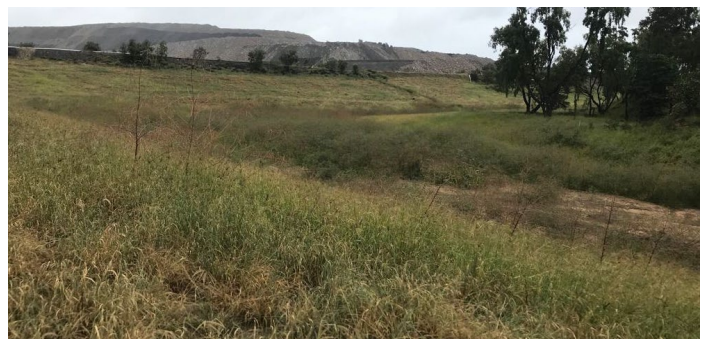
*In follow-up inspections, the site had impressive growth*

- Within three months the site had established vegetation
- The site owner was impressed with the solution and is now installing ProGanics BSM on more than 20 hectares (49 acres)
