# Working With Nature

## Green erosion control solution protects waterways & steep slopes

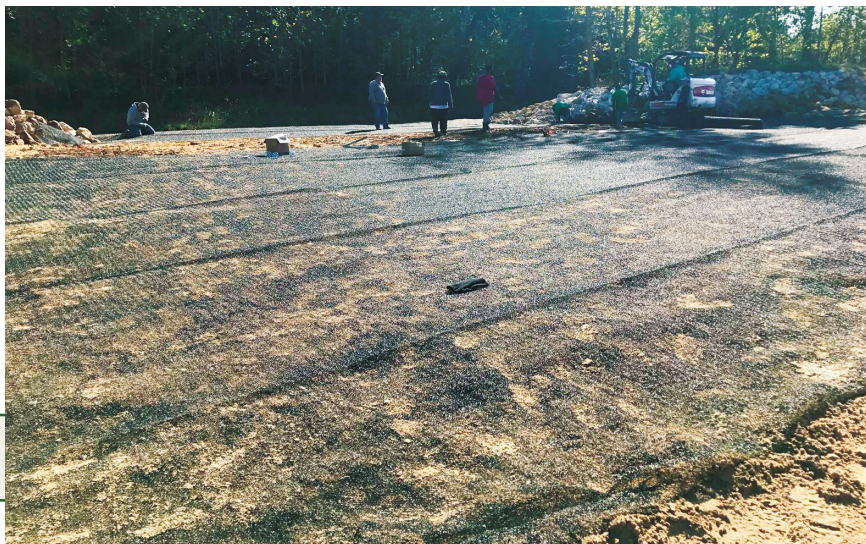
**The turf reinforcement mat encourages growth.**

Stuckey's LLC then had to address the variety of erosion issues on the site. Starting with the area where the bank collapsed from the high hydraulic shear forces, Stuckey's LLC selected GreenArmor system 7010. The system works with a Futerra 7010 turf reinforcement mat (TRM) to provide a permanent, lofty and open matrix. This TRM consists of 95% open space and encourages growth. It then is hydraulically infilled with Flexterra high-performance flexible growth medium. Flexterra is designed with thermally refined wood fibers and biodegradable interlocking fibers that firmly anchor seed to soil. When combined with the Futerra TRM, Flexterra provides resistance to shear force while vegetation is establishing. System 7010 is

designed to withstand shear stresses of up to 8 lb per sq ft and velocities of up to 14 ft per second. Downstream, where the flow was not as strong, Stuckey's LLC used Flexterra on the floor of the drainage path.
