# Project profile: Camelback Golf Club - Scottsdale, Arizona

## PROJECT SUMMARY

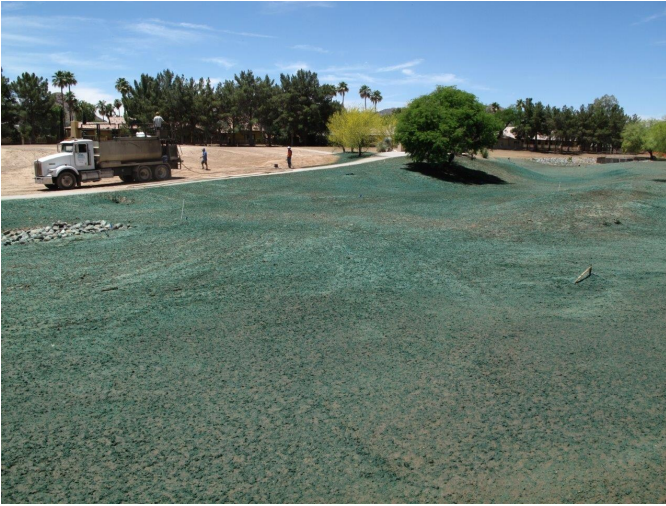
*Hydroseeding course with Terra Wood and native seed blend*

Profile recommended effective solutions to stabilize slopes, promote vegetation, and improve the long-term viability of the rootzone mix. Fairways were hydrosprigged with Bermudagrass and Profile's Terra Wood™, while the perimeter areas were hydroseeded conventionally using Terra Wood along with native grasses, and a Wildflower mix in select areas to provide a unique feel to the course. Additionally, Profile Porous Ceramics—Greens Grade was selected as the soil amendment for the root zone mix and incorporated at a 10% rate. Testing of the root zone mix was completed by Hummel Labs, and based on the characteristics of the sand, a 90/10 sand/Profile blend was selected to ensure optimum performance.

While the Arizona climate was favorable for growing, the potential for rain impact on the flood plain led hydroseeding contractor Rob Everhart to utilize Wood Fiber mulch at a rate of up to 2400 lbs/acre. He also added a tackifier when applying the native grasses and wildflowers, particularly on the greater slopes.

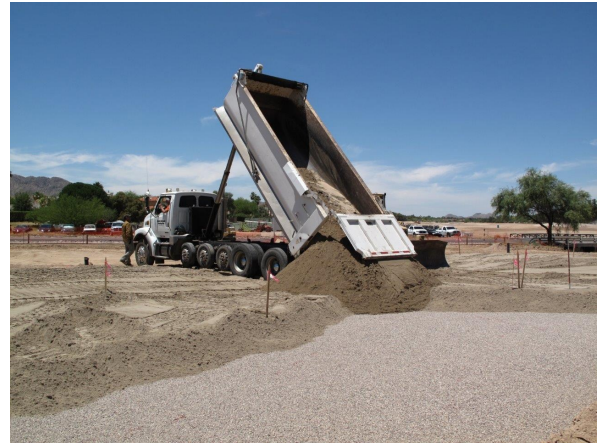
*Sand / Profile Blend unloaded for root zone mix installation*

Profile Porous Ceramics were  
incorporated at a 10% rate by  
volume on Greens;  
Champion Bermudagrass was  
hydrosprigged on Greens

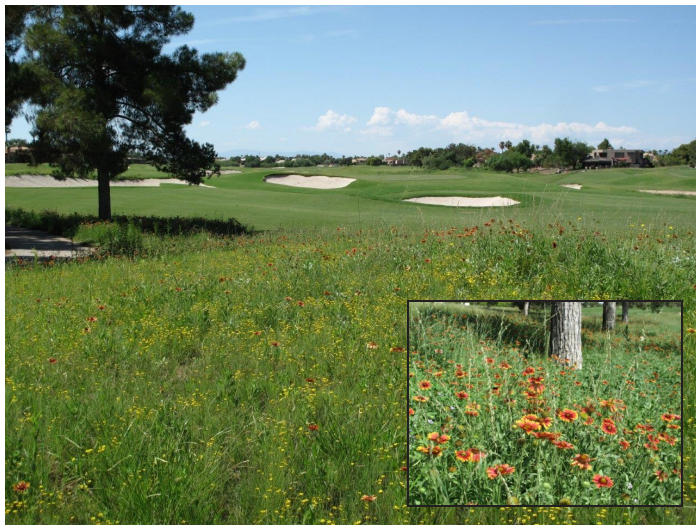
*Wildflowers fully grown in after hydroseeding*

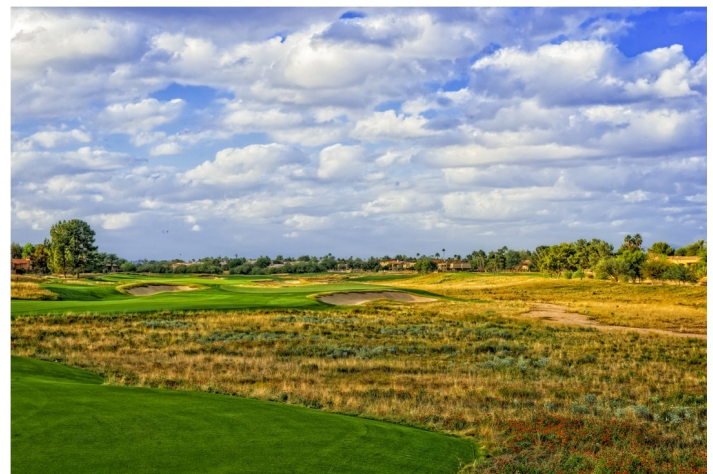
*Native grasses grown in on course  
Photo credit: Dave Sansom—copyright 2013*

"The native areas germinated and  
grew in quicker than we expected,  
largely in part due to the excellent  
performance of Profile's Terra-  
Wood product; and the putting  
greens were exceptional for a first  
year course."
