## PROJECT STAKEHOLDERS

- North Canterbury Transport Infrastructure Recovery (NCTIR)
- Contractor: RST Environmental

In November 2016, a 7.8 magnitude earthquake hit New Zealand near the tourist town of Kaikoura. More than 85 landslides damaged 194 kilometers (120 mi) of road and 150 kilometers (93 mi) of rail. The government immediately created the North Canterbury Transport Infrastructure Recovery (NCTIR) team and began planning how to restore access to state highways and railways. While NCTIR worked to quickly remove debris from the roads and rails, Profile® and PGG Wrightson Turf met with project consultants to determine how to stabilize the rocky slopes and prevent future landslides. Profile hosted a Lunch & Learn with the environmental recovery team and demonstrated the value of ProGanics® Biotic Soil Media™ (BSM™) and Flexterra® High Performance-Flexible Growth Medium® (HP-FGM®) for this site. ProGanics is an Engineered Soil Media™ (ESM™) that provides organic matter and soil-building components to modify the soil chemistry and initiate growth and sustain vegetation. Flexterra is the industry's leading hydraulically-applied erosion control product, which prevented erosion

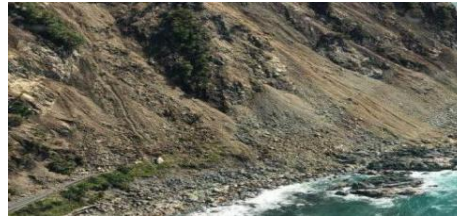
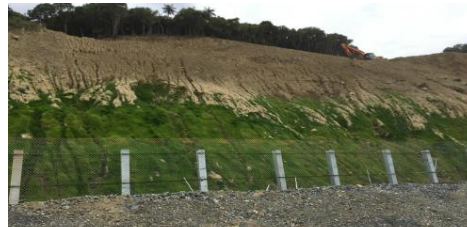
*Top: Immediately after the earthquake  
Bottom: Vegetation fully established  
on hydroseeded portion of slope 2 months  
after application*

- The roadside berms and slopes established vegetation within a few months
- Despite heavy rainfall from a tropical storm, the reclaimed sections withstood the intense storms

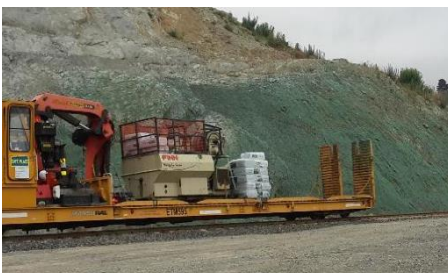
*Applying Flexterra to the steep slopes*

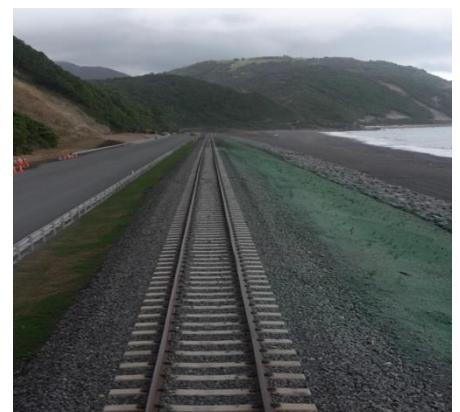
*Flexterra application along the  
road and railways*
